To: ARCF_SEIS@usace.army.mil
Cc: PublicCommentARCF16@water.ca.gov
Subject: Comments Regarding American River Common Features (ARCF) 2016 Draft Supplemental Environmental Impact Statement/Subsequent Environmental Impact Report (SEIS/SEIR) – December 2023 Report and Appendices; Specific Comments Pertaining to Hydrology, Erosion, etc.
9 February 2024

The extensive comments detailed below focus on the Lower American River projects of the draft SEIS/SEIR, particularly Contracts 3B, 4A and 4B, and were generated and vetted, after careful review of all available documents, by a team of qualified active and retired civil engineers, an emeritus CSUS professor, PhD in Biological Sciences, and a UCD PhD candidate in the history of Sacramento Valley flood control. The comments herein were further vetted by an attorney.

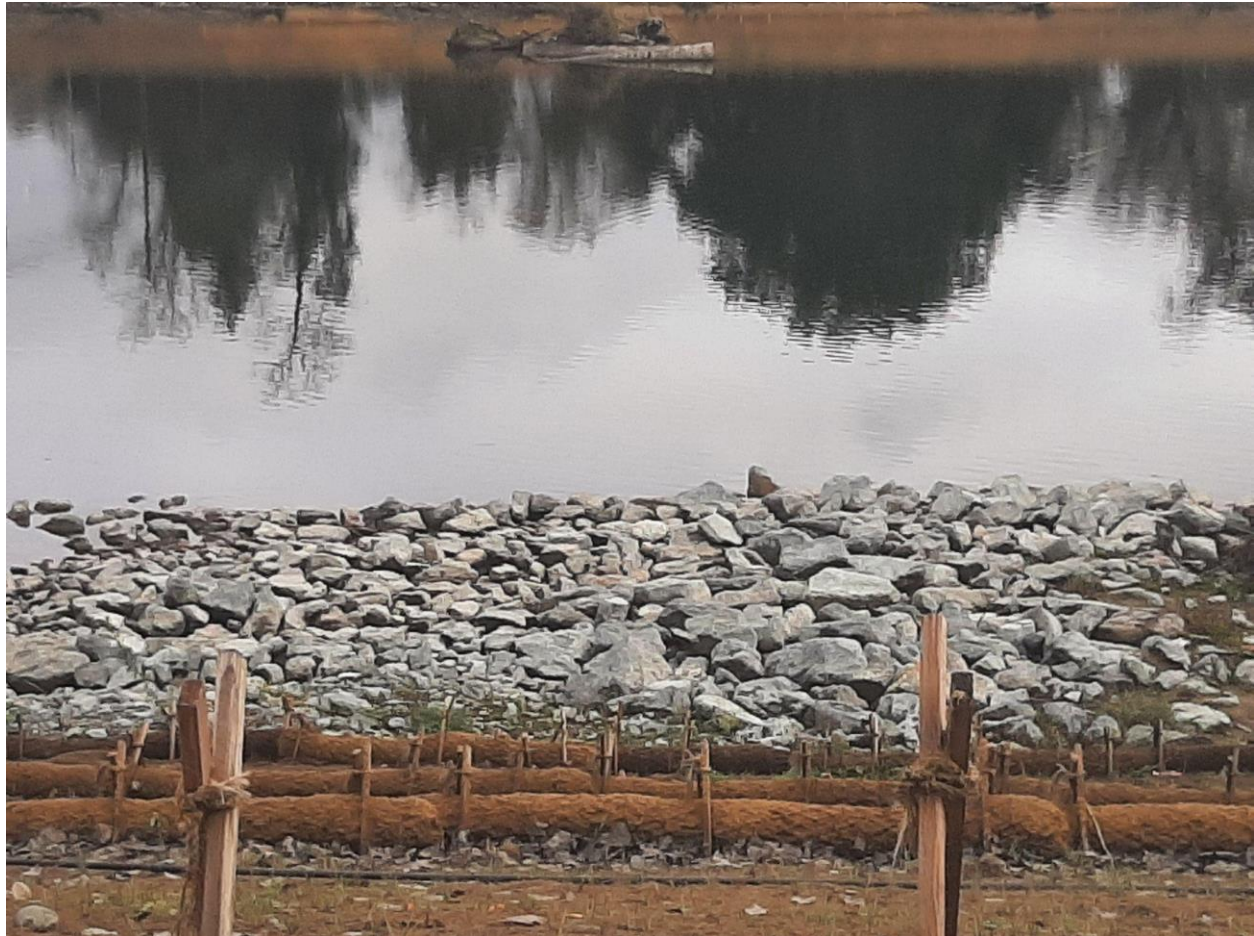
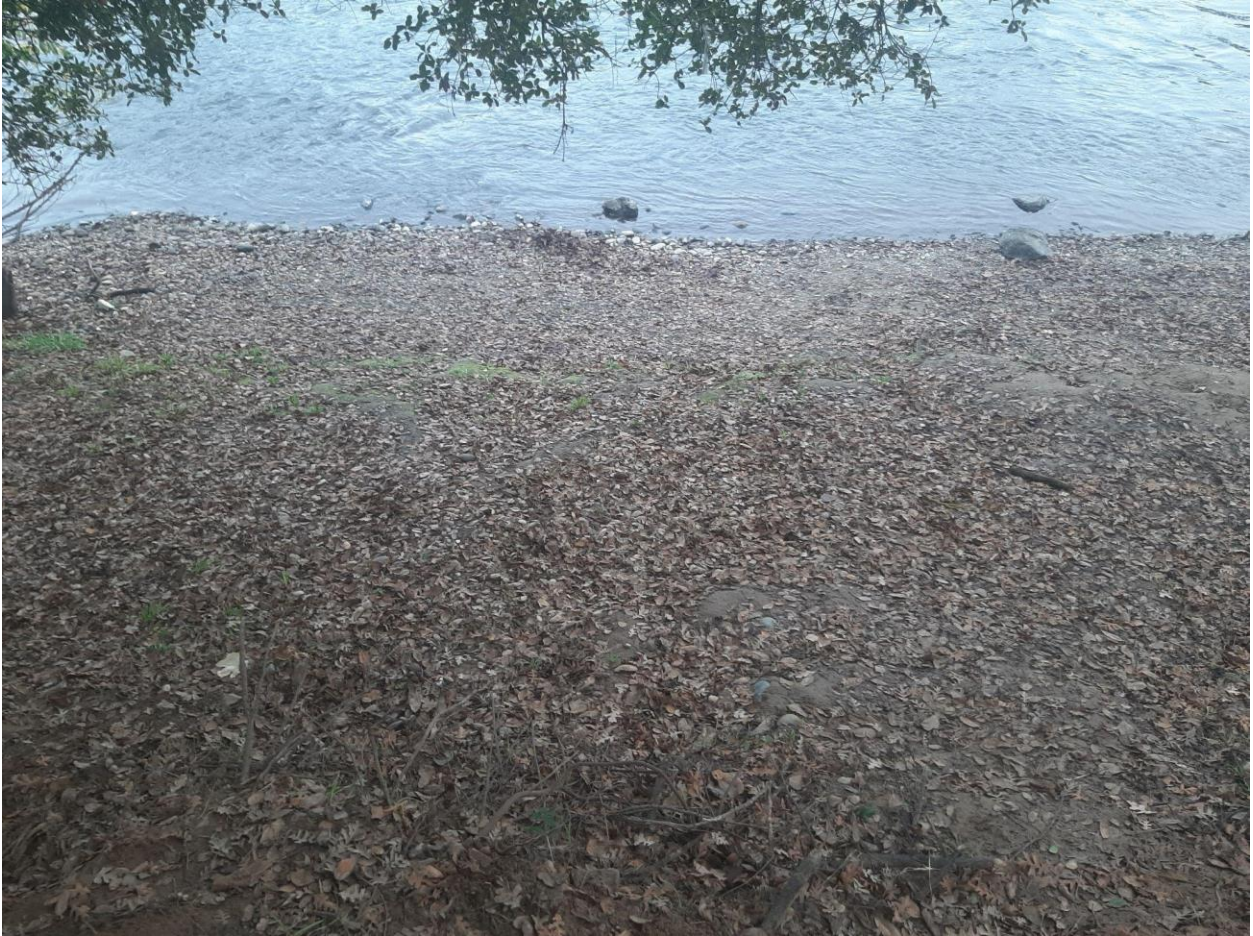
Example of launchable rock toe near Sac State

A beach in front of Larchmont Community Park that will be made inaccessible by the Launchable Rock Toe. USACE has not addressed lost beaches due to launchable features.

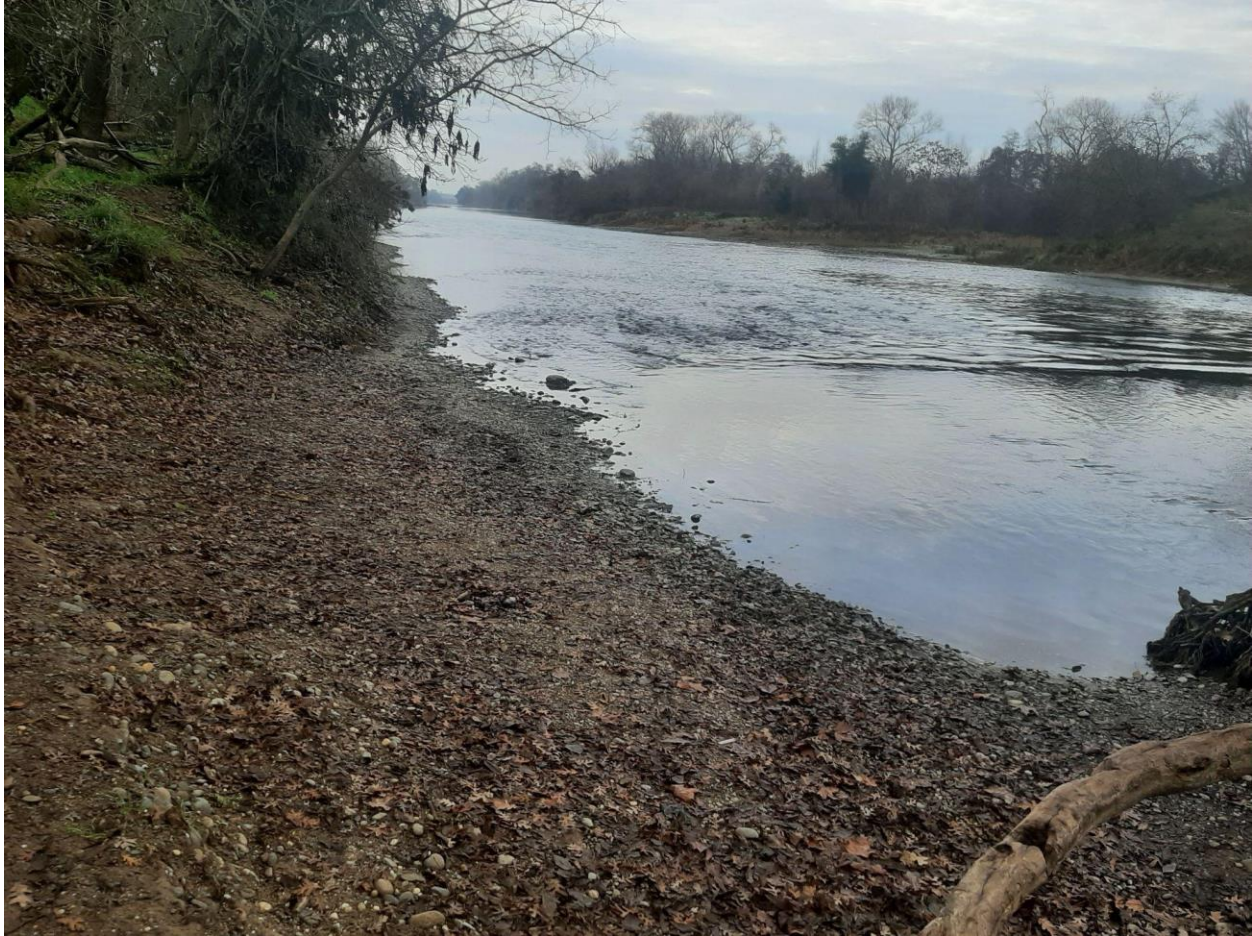
A beloved beach in front of Larchmont used for launching canoes, fishing, swimming, and watching the sunset.

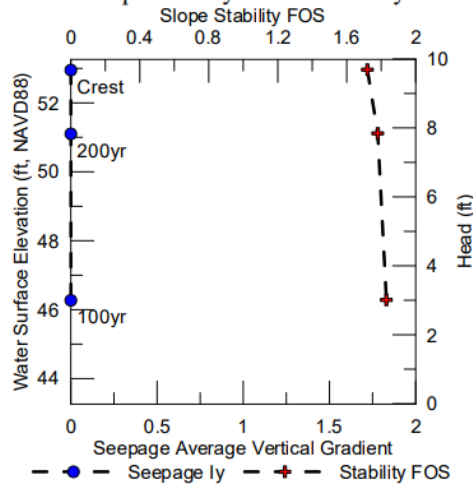
Figure 10-1: ARN Reach A U9 LM 1.32 Without Project Analyses Results

The without project conditions analyses includes the WRDA 1996/1999 cutoff wall and met criteria for both seepage gradients and slope stability factors of safety. **As no seepage and stability deficiencies exist, no further improvements are recommended.** Figure 10-1 displays steady state seepage and landslide slope stability results for analyzed flood frequencies.

- e. Geotechnical Report, 2016 GRR, Figure 10-1, Appendices Page 705
 - i. "As no seepage and stability deficiencies exist, no further improvements are recommended."

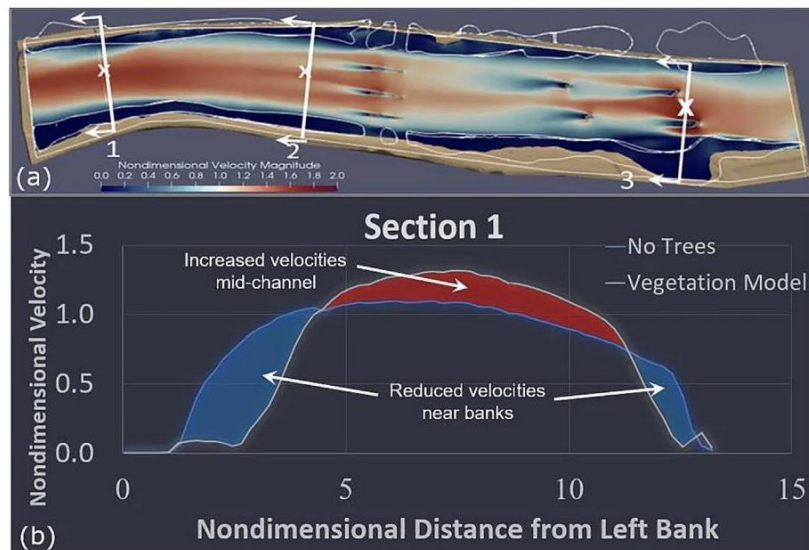
FIGURE 7 Cross-sections were compared along three locations of the American River (a). At Section 1-1, the vegetation model significantly damped out flows along both banks (blue regions) and increased velocities in the centre of the channel (red region) compared to LES without trees (b).

9. Modern advanced modeling also shows that trees protect banks by redirecting the energy of a river towards the center of its channel. Removing these trees may exacerbate erosion and make us less safe. Because of large trees, the water along the river banks in this part of the river during a storm is stagnant. It does not move fast enough to scour the banks. Kevin Flora and Ali Khosronejad found that at the cross-sections of three locations of the American River, trees significantly reduce velocity flow

along both banks, while increasing velocities in the center of the channel. (A) Empirically, this is confirmed by a photo showing a dog wading in the waters (see picture) along the riverbank in front of Larchmont Park during the 80,000 cfs high water mark in 2017. This empirical evidence is further confirmed by velocity contour maps provided by the Sacramento Area Flood Control Agency in a report prepared by MBK Engineers called "The 2017 Lower American River Stream Bank Erosion Report." These velocity contour maps show that during 145,000 cfs flows, the velocity along the banks between River mile 10.5 and 11, an area that encompasses the proposed project footprint in front of Larchmont Community Park, is only expected to be 0-2 feet per second, well below any velocity that could scour the banks. (B) However, if USACE removes large trees to install launchable features, water will move along the banks much faster.

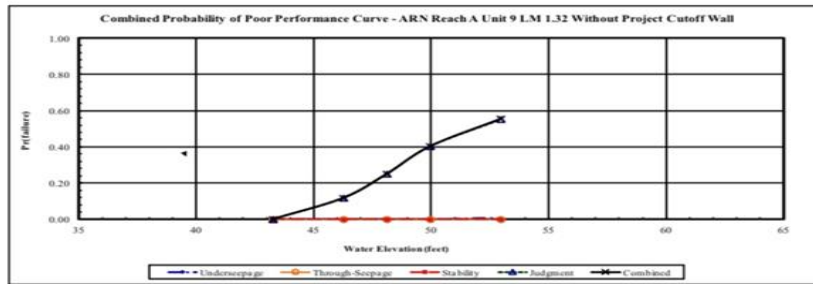
Figure 17-1: Combined Probability of Poor Performance for Without Project Conditions

The levee embankment contains an existing cutoff wall which mitigates underseepage, through seepage, and slope stability concerns. The without project judgment based probability portion of the curve was comprised mainly of erosion, and encroachments, accounting for 50.0% and 4.0% respectively at the crest. Past performance has indicated significant amounts of erosion of the riverbank, waterside levee slope and foundation. Overall judgment based contributions account for a Pr(f) of 55.3% of the without project combined curve at the levee crest. Figure 17-1 presents the without project conditions combined curve.

3. Section 17.0 portends to apply a “probabilistic analysis” and provides graphs to show the increase in performance of the levees, as if this can be quantified with mathematical precision. However, the analysis itself includes a judgement factor (Geotechnical Report, page 31 of 48): “A judgment based conditional probability function for each analyzed cross-section was based on existing conditions of the levee such as encroachments on the levee slopes, vegetation on the levee slopes and in the vicinity of the levee toes, existing cracks and holes due to animal burrows, erosion of the waterside levee slopes and riverbank, and considering the past history of sand boils or slope failures. Generally, past experience with poor performance at utility crossing and rodent activity indicates the risk of failure is somewhat significant in the analyzed areas.” Therefore, the graphs themselves are misrepresentative; engineering judgement and observations are important, but they cannot be quantified and should not be presented as such.

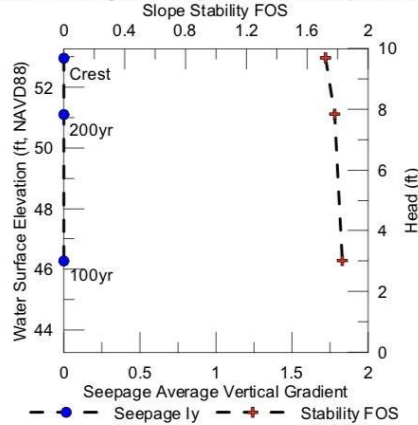
Figure 10-1: ARN Reach A U9 LM 1.32 Without Project Analyses Results

The without project conditions analyses includes the WRDA 1996/1999 cutoff wall and met criteria for both seepage gradients and slope stability factors of safety. As no seepage and stability deficiencies exist, no further improvements are recommended. Figure 10-1 displays steady state seepage and landside slope stability results for analyzed flood frequencies.

Just upstream
House Ave Bridge
N. Side

1. Geotechnical Report, 2016 GRR, Figure 10-1, Appendices page 705, in the text above Figure 10-1, reads: "As no seepage and stability deficiencies exist, no further improvements are recommended." Therefore, the Geotechnical Report refutes the need for erosion protection at Howe Avenue to prevent seepage.
